Photographs for Mid City Plating Company CEI 6/22/2010

Media: RCRA

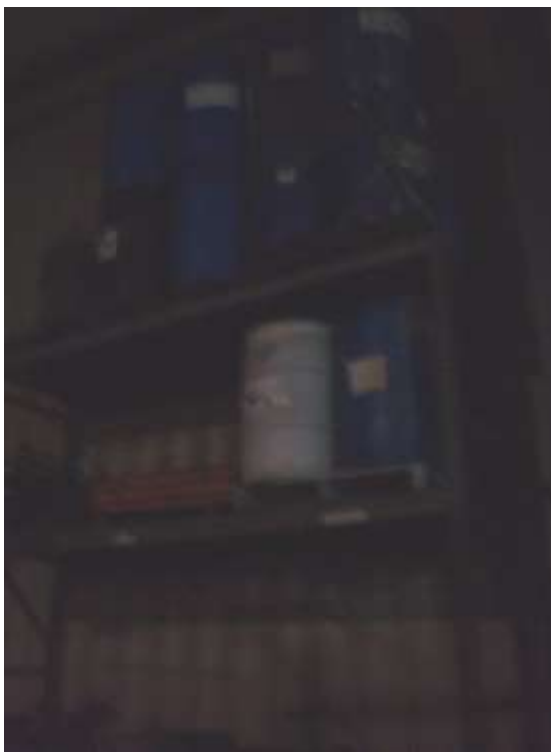
55-gallon containers and other types of containers were being stored on a 3-tiered shelving unit. The containers were described as storing raw materials.

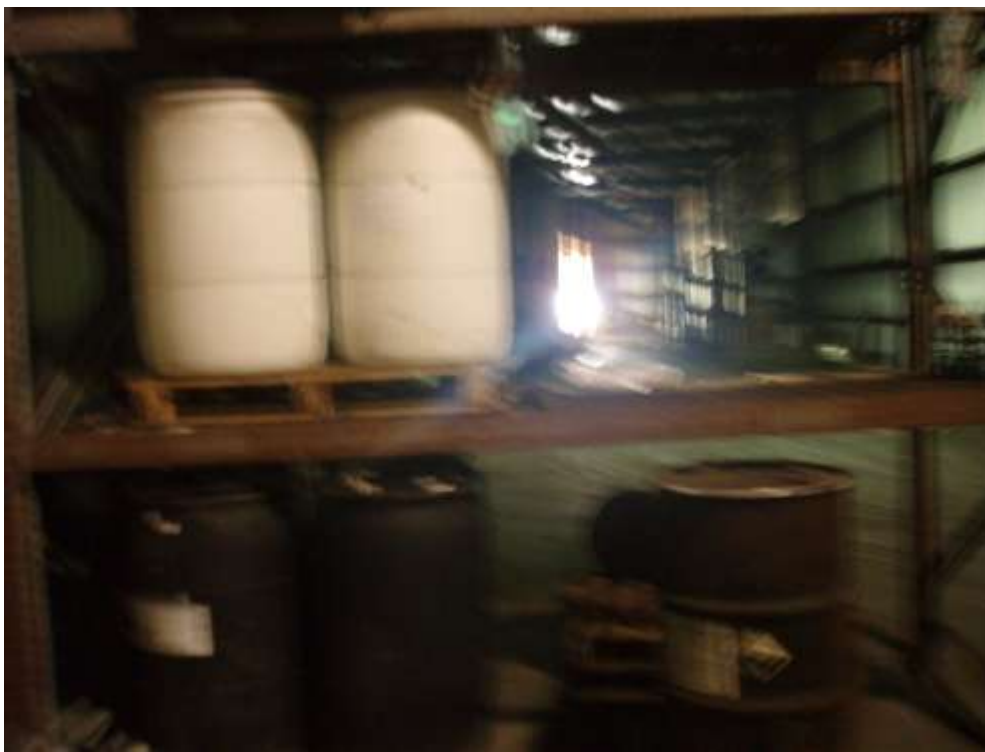
Raw material storage.

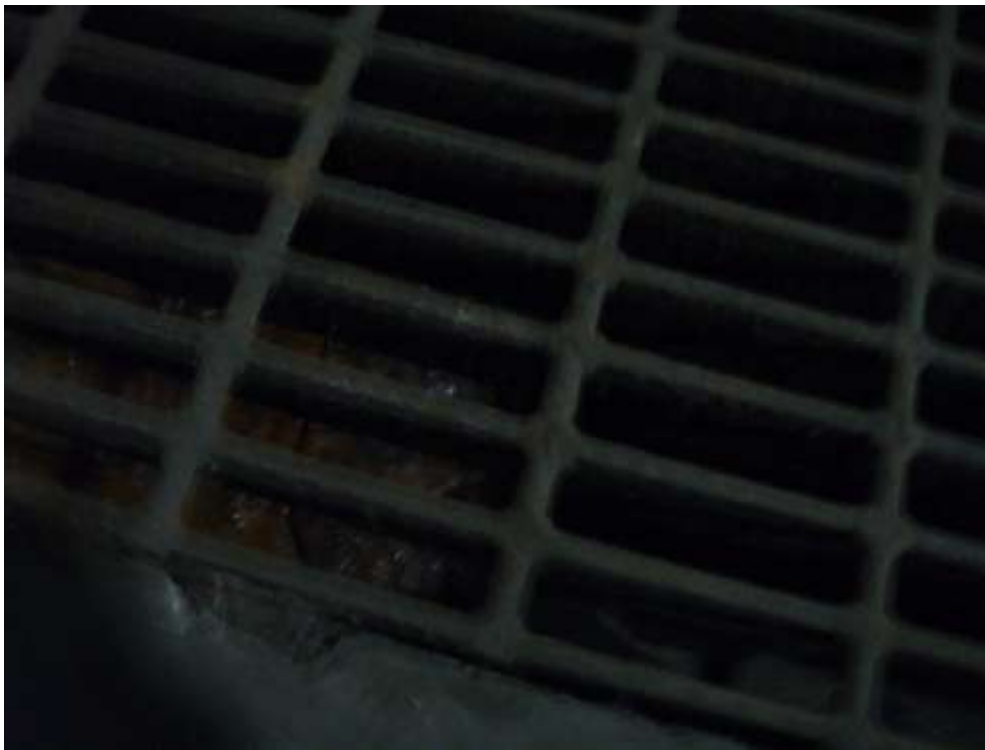
A pit, with a grate, was located near the WWT unit waste water storage totes. A 4-inch thick un-identified solid material was located in the bottom of the pit.

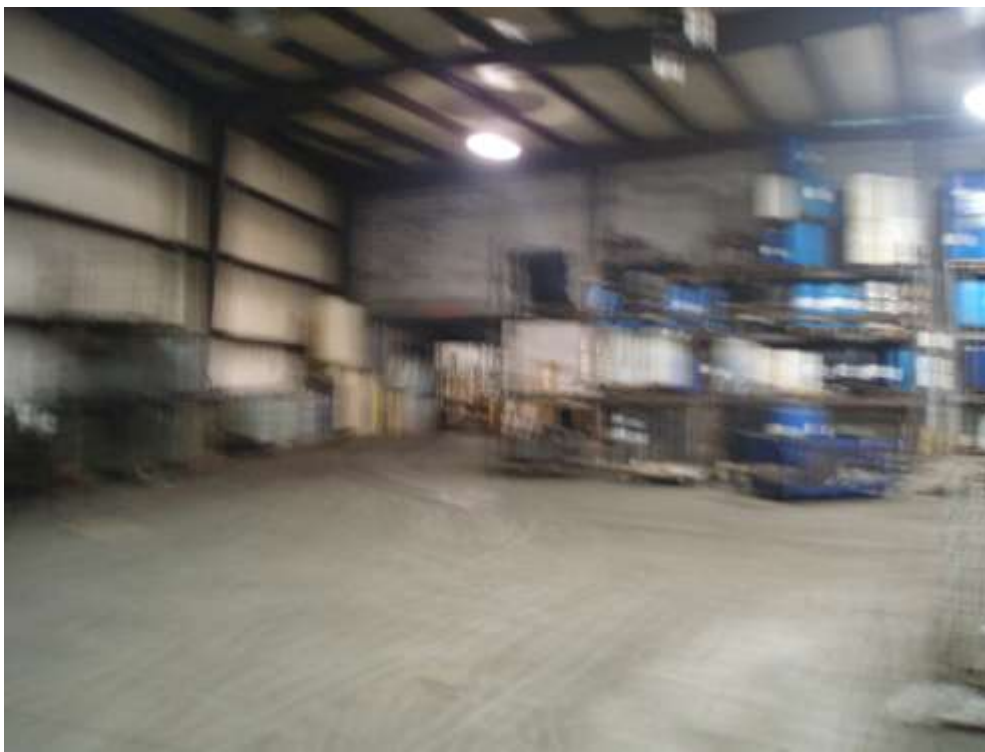
3-tiered shelving unit storing 55-gallon containers. Containers were described as empty.

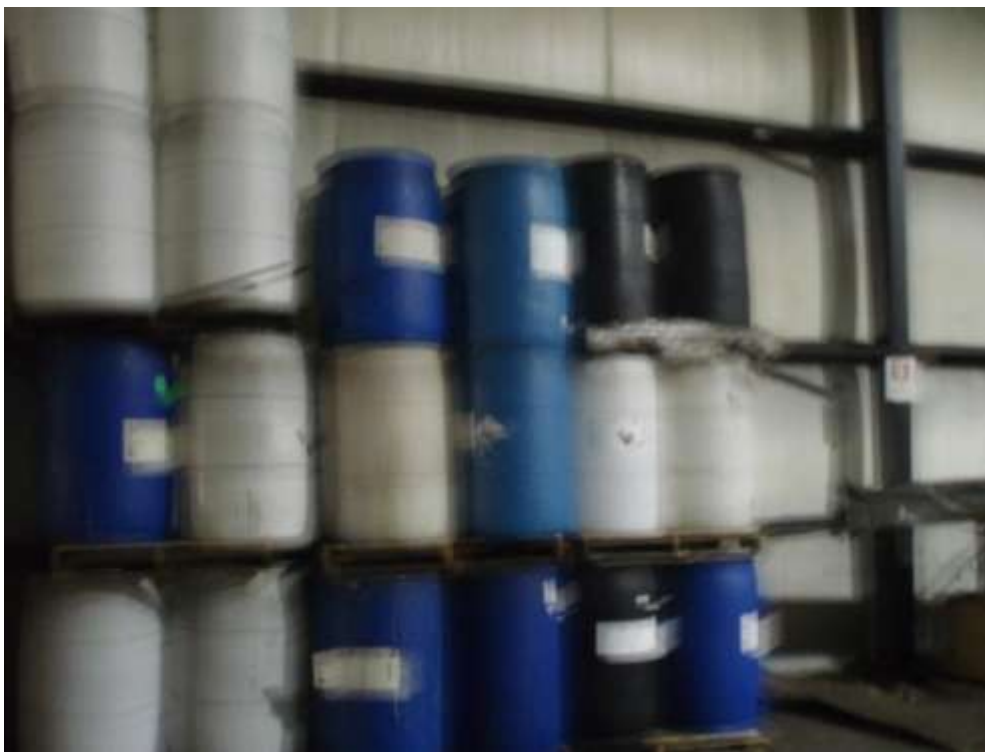
55-gallon containers were beings stored along the South wall. The containers were described as either empty or containing "working solutions."

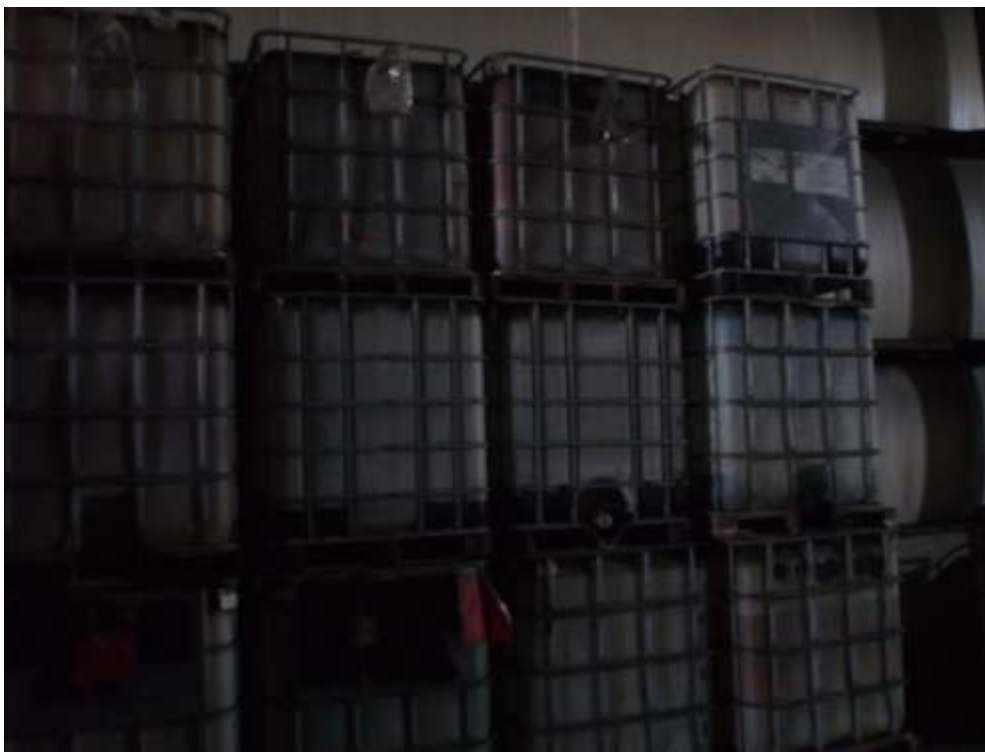
Totes were being stored and stacked along South wall. The totes were storing "working solutions."

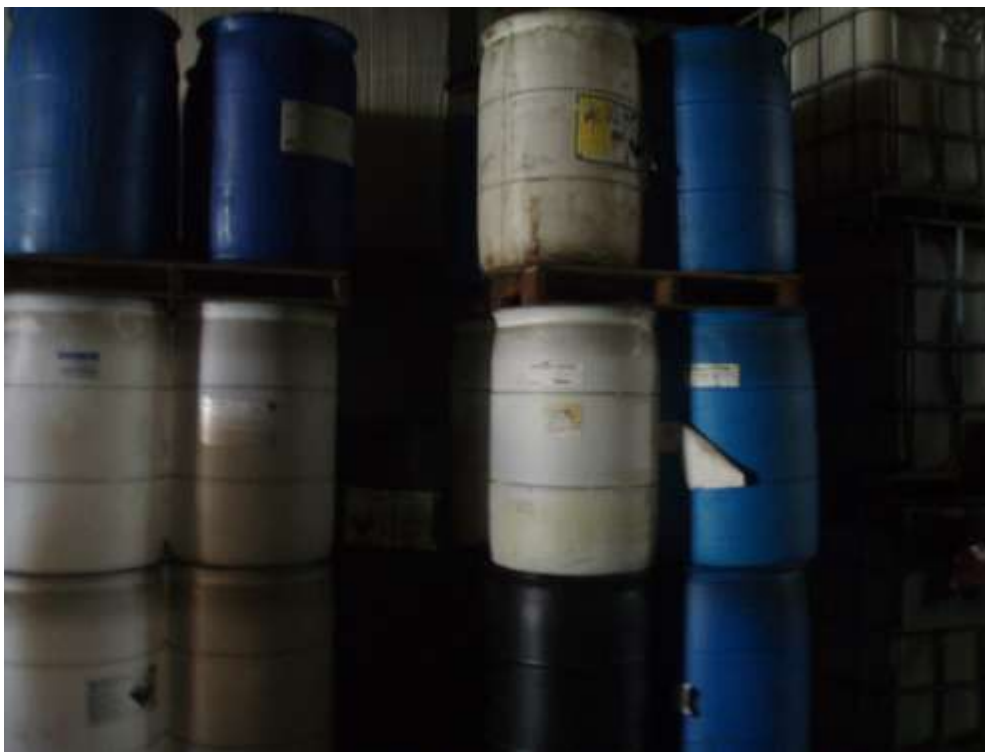
55-gallon containers were being stacked and stored next to the totes, along the South wall. The containers were described as being empty.

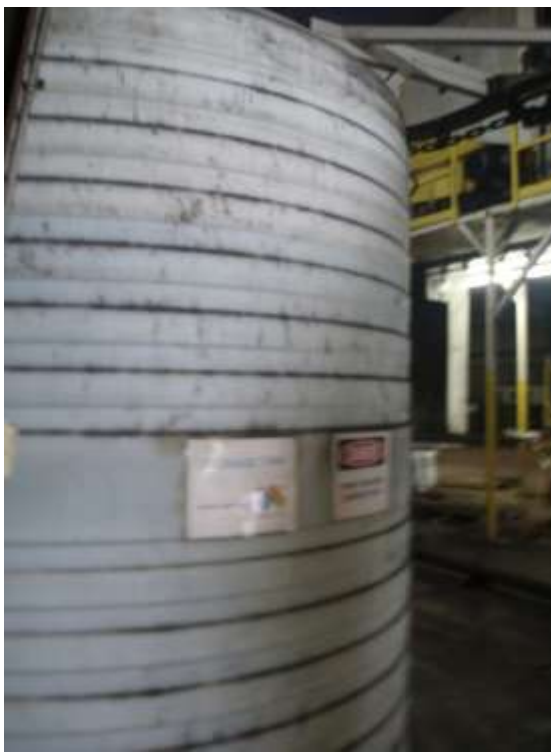
City water storage tank. Water to be used in
E-coat system.

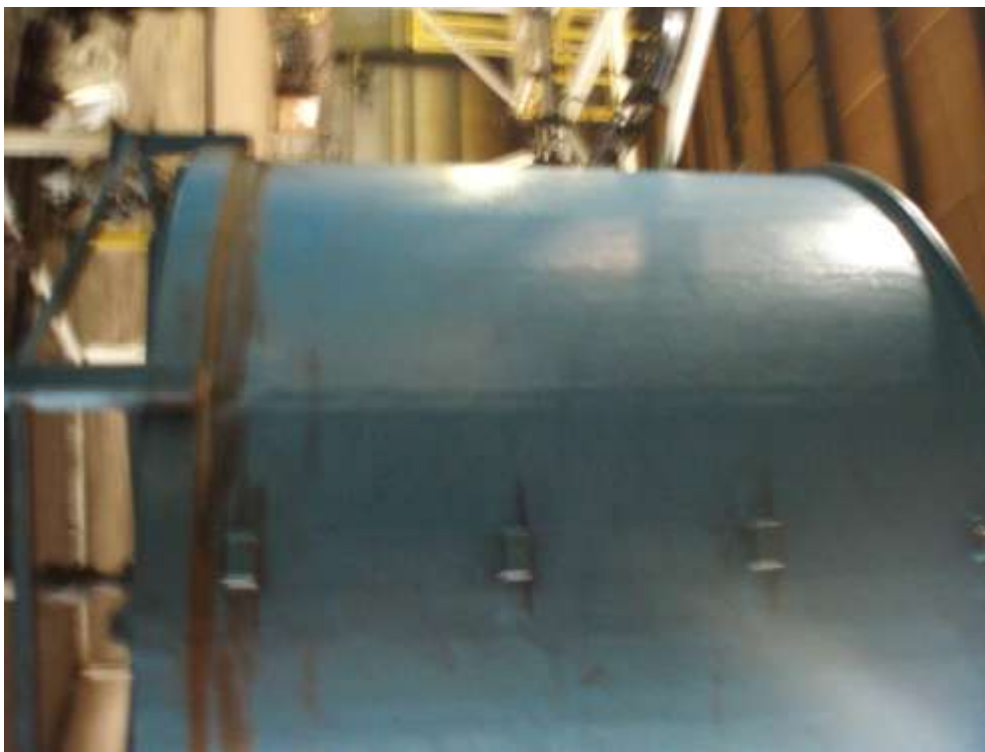
10,000 gallon E-coat line crash tank to be used in emergencies. The tank was described as empty; however will be used to collect E-coat line material(s) in cases of emergencies.

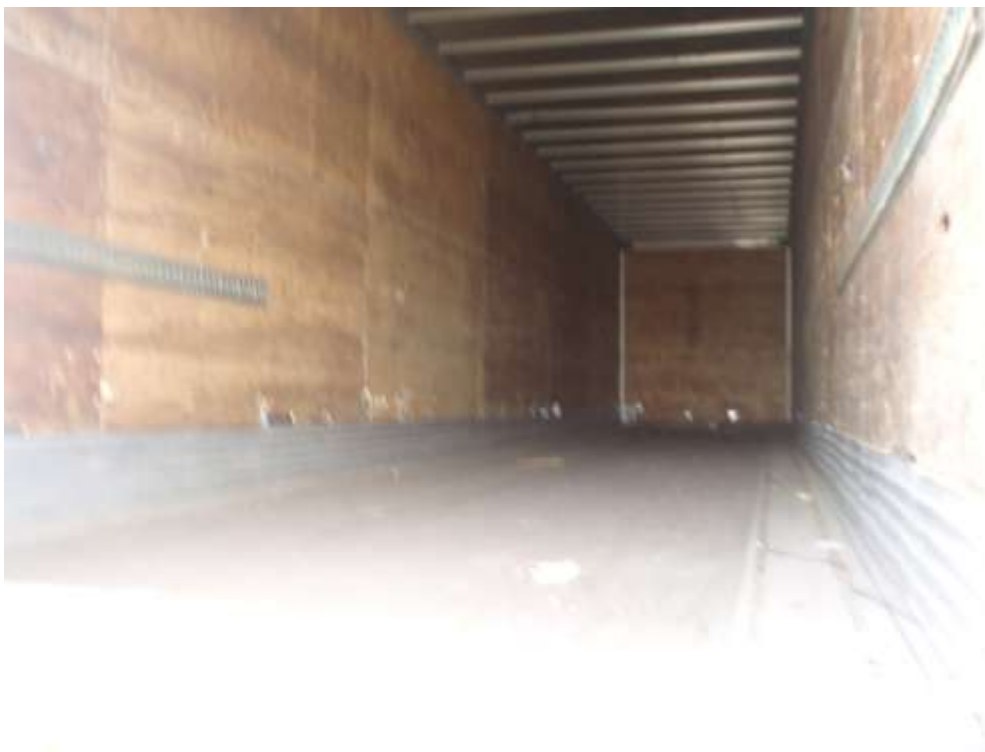
Four trailers were located outside on the East side of the facility. Trailer 1 was empty.

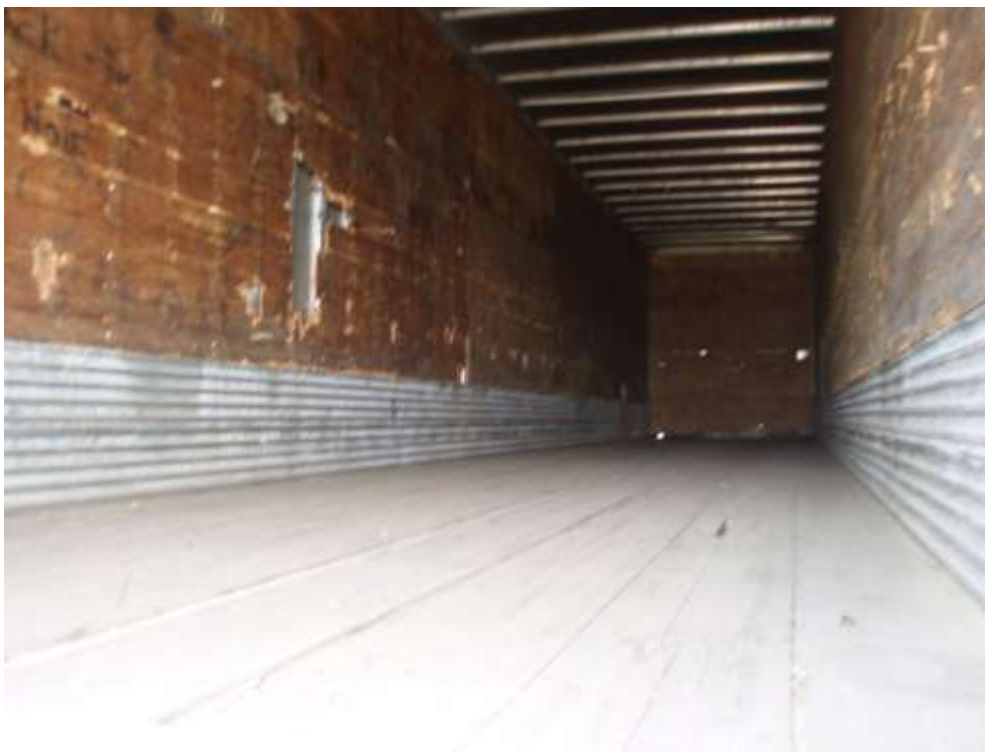
Four trailers were located outside on the East side of the facility. Trailer 2 was empty.

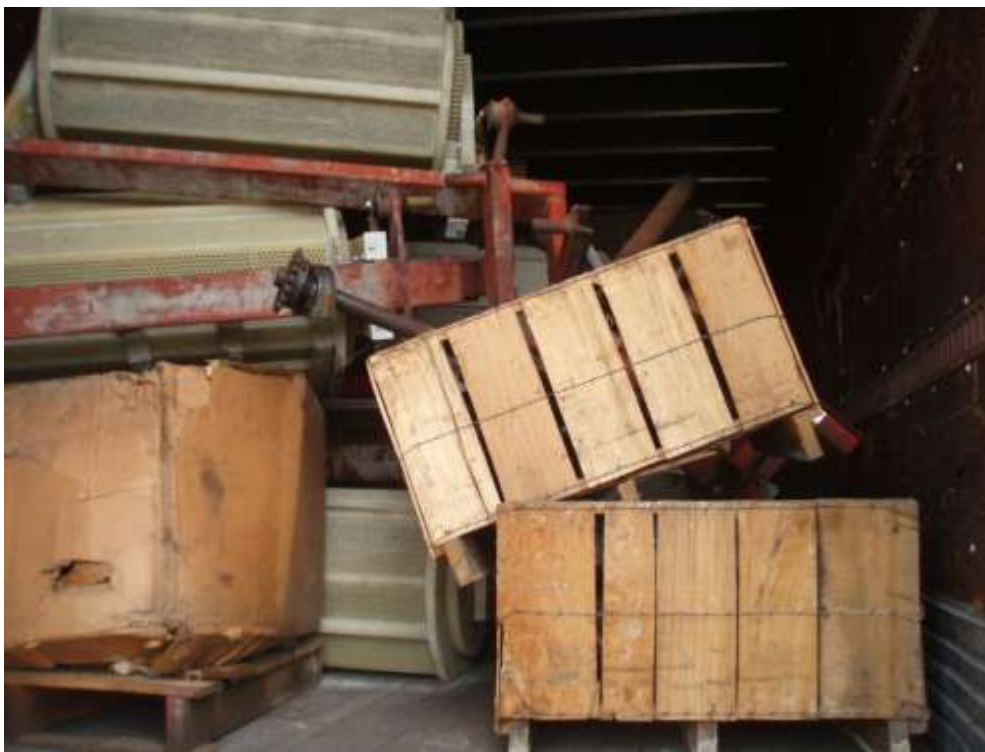
Four trailers were located outside on the East side of the facility. Trailer 3 was being used as storage and contained Barrel line equipment.

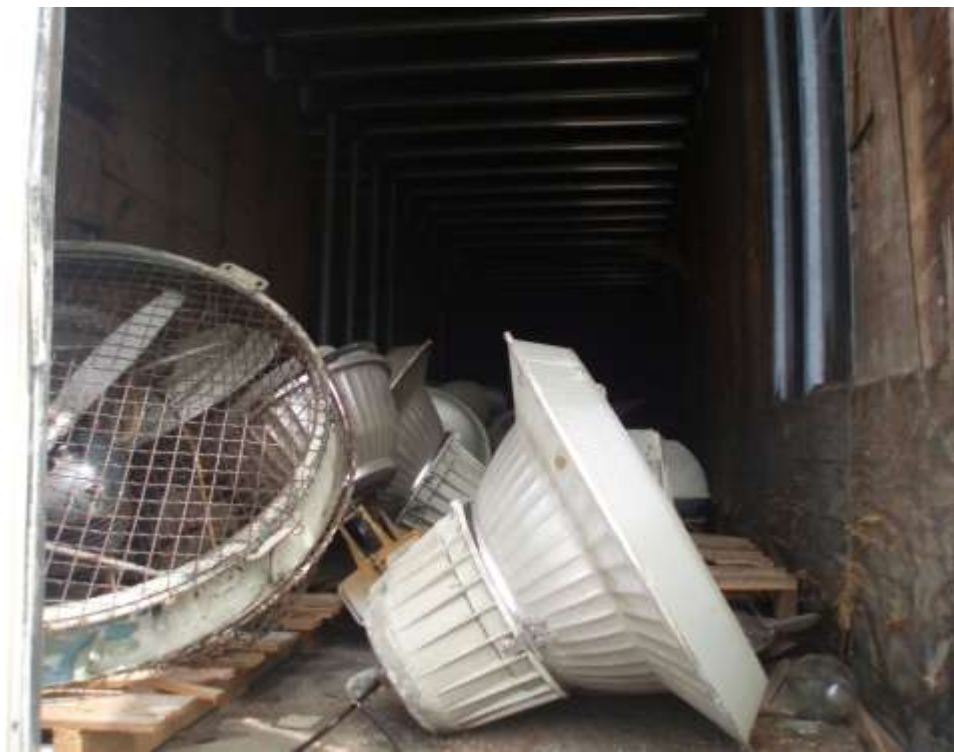
Four trailers were located outside on the East side of the facility. Trailer 4 was being used as storage and contained fans and light fixtures.

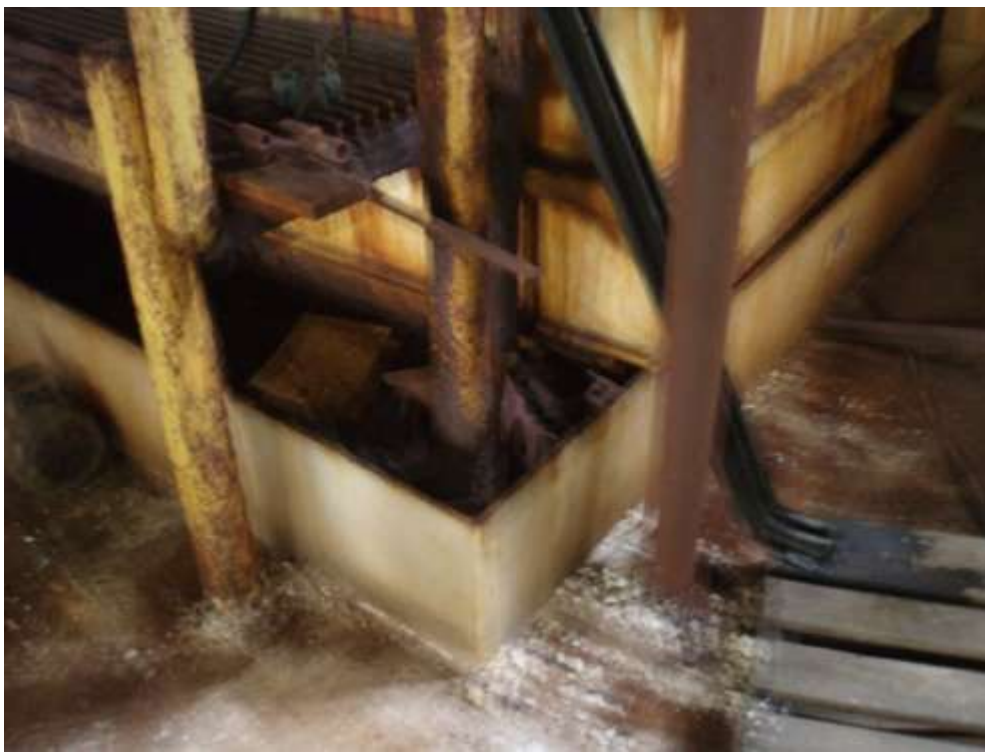
Barrel Row and Strip Line. Containment pit.

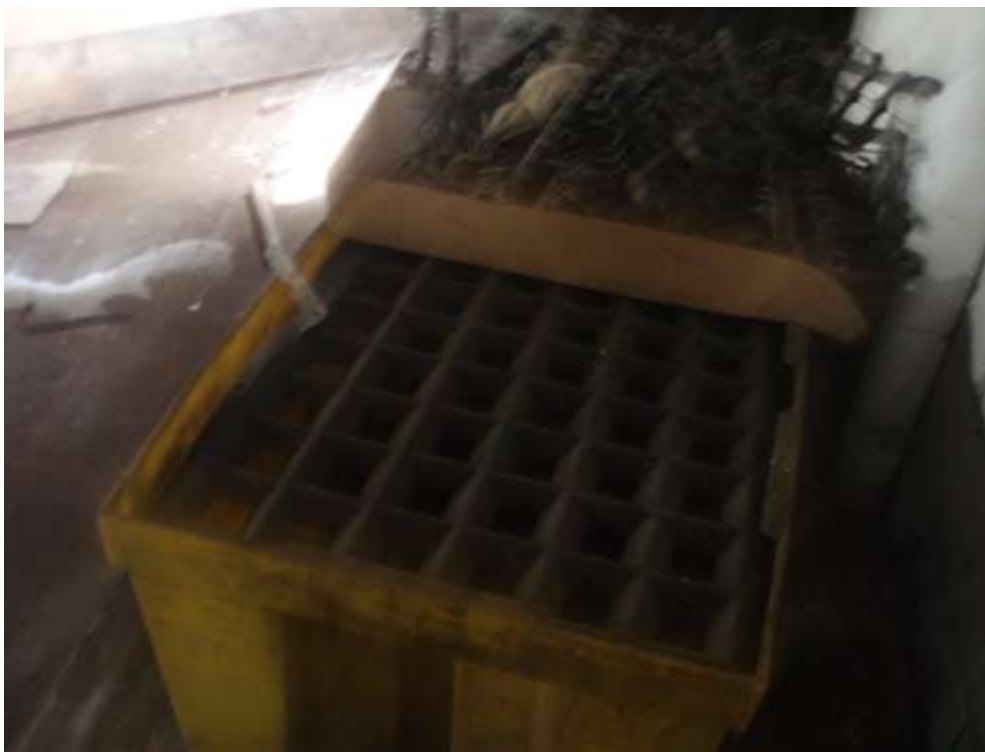
Barrel Row line equipment and pallet being stored.

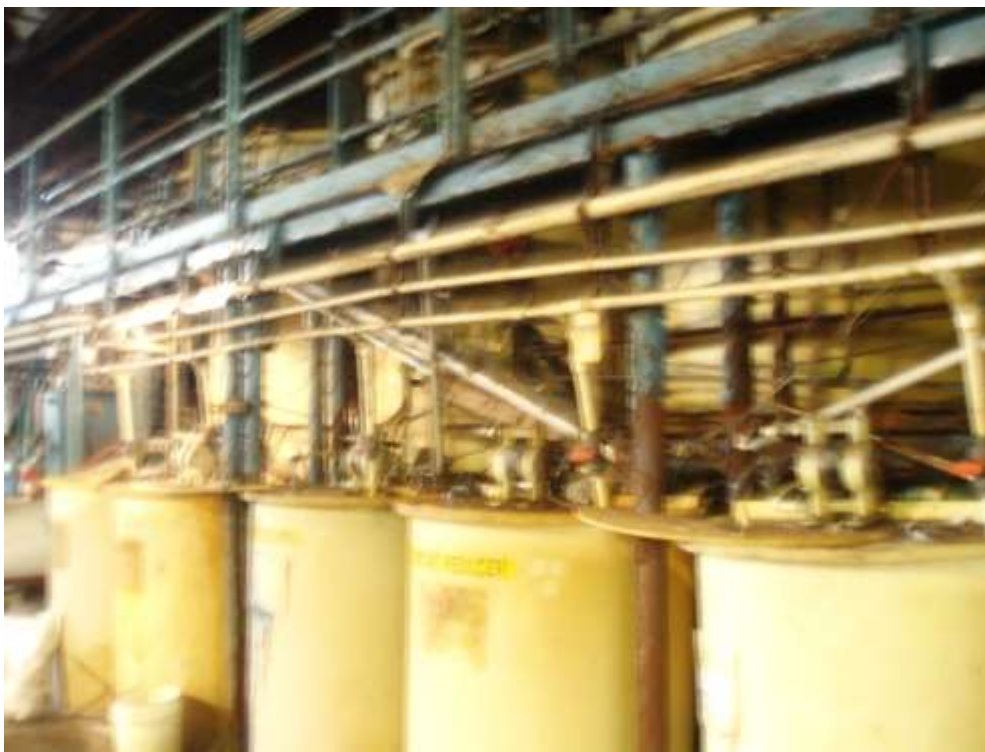
WWT unit.

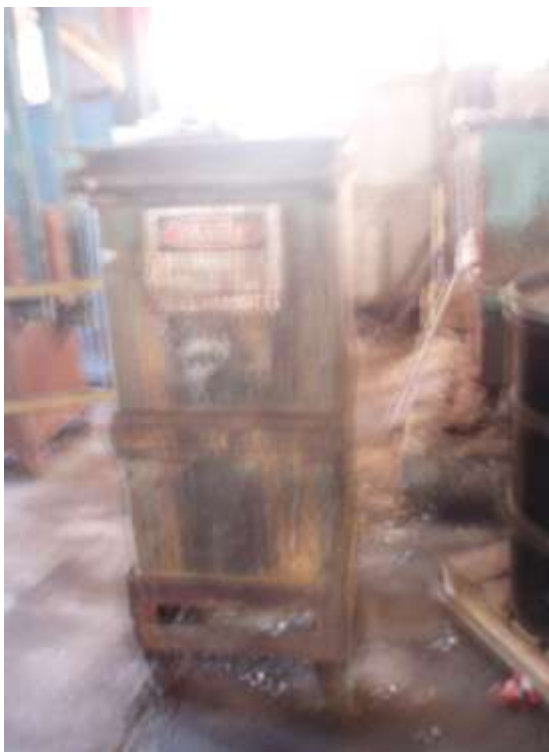
Chromate solution. "Working Solution."

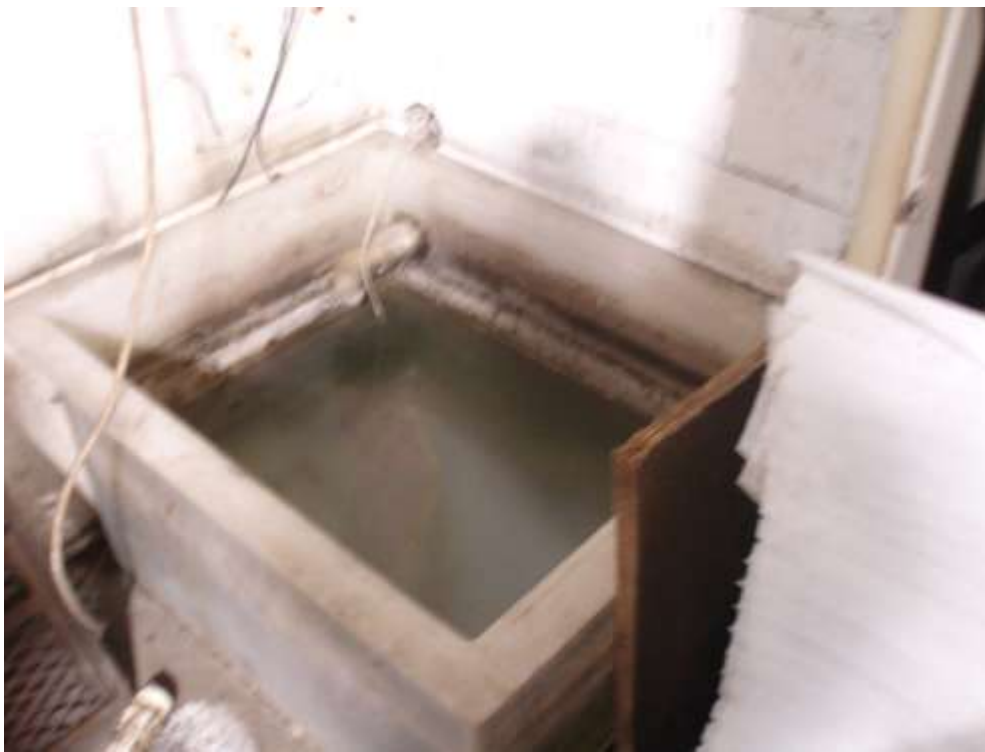
Laboratory water.

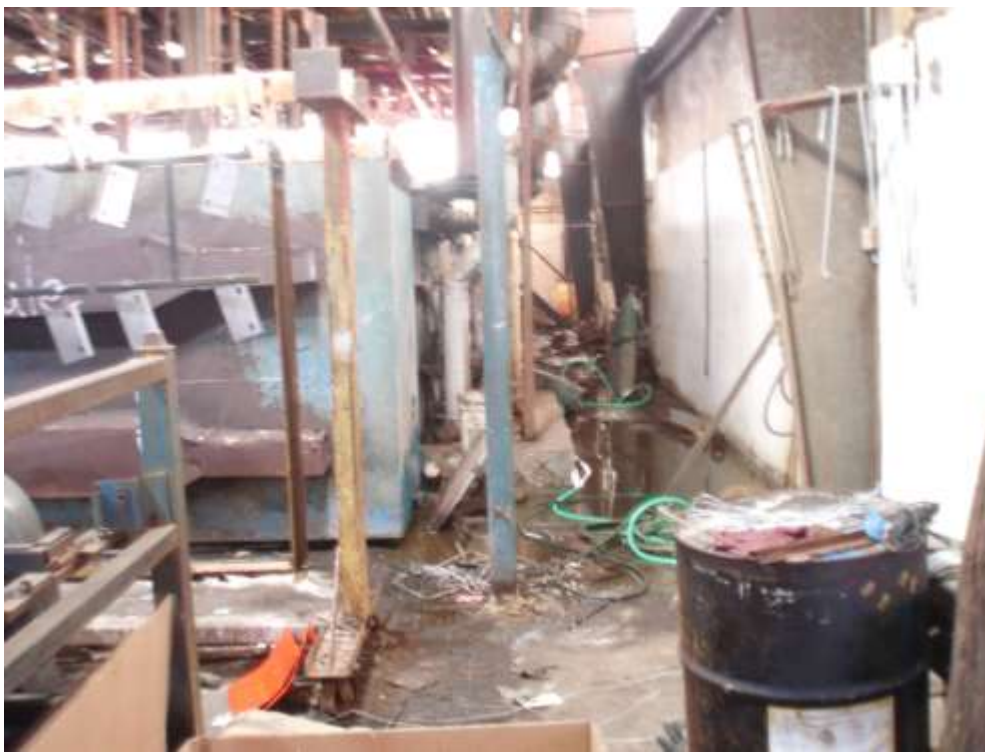
Zinc plating line. Liquid was located on floor near the line. Hoses and equipment were also located on the floor.

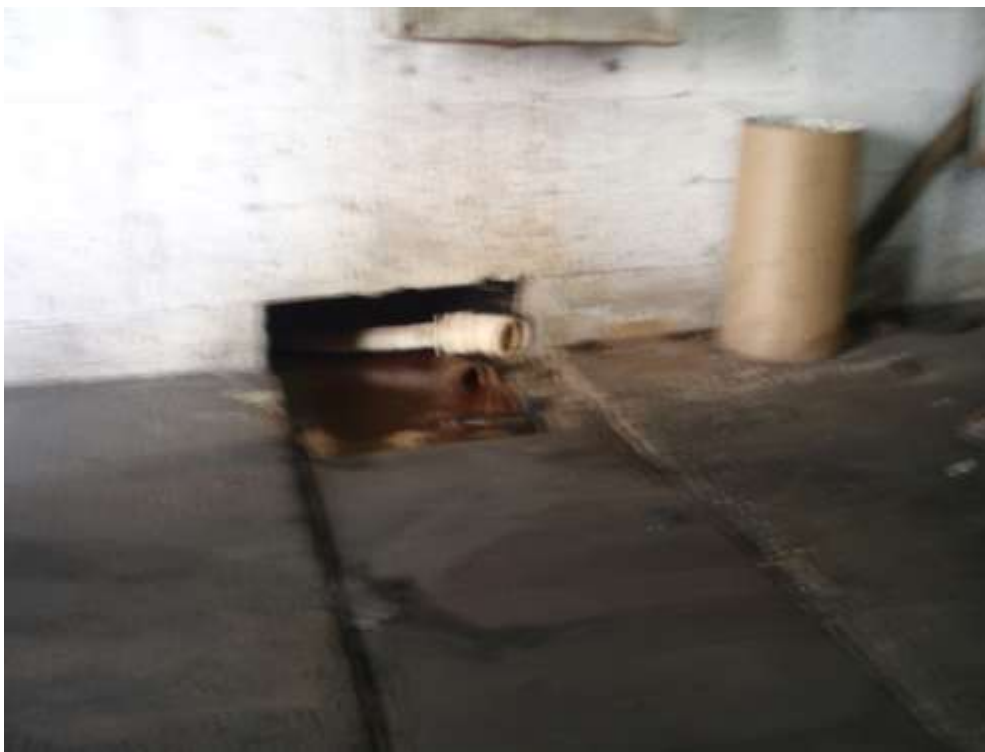
Trench located on the floor in between rooms. Red un-identified red liquid was being stored within the trench. Pipes were located inside of the trench and were not connected from the exposed ends.

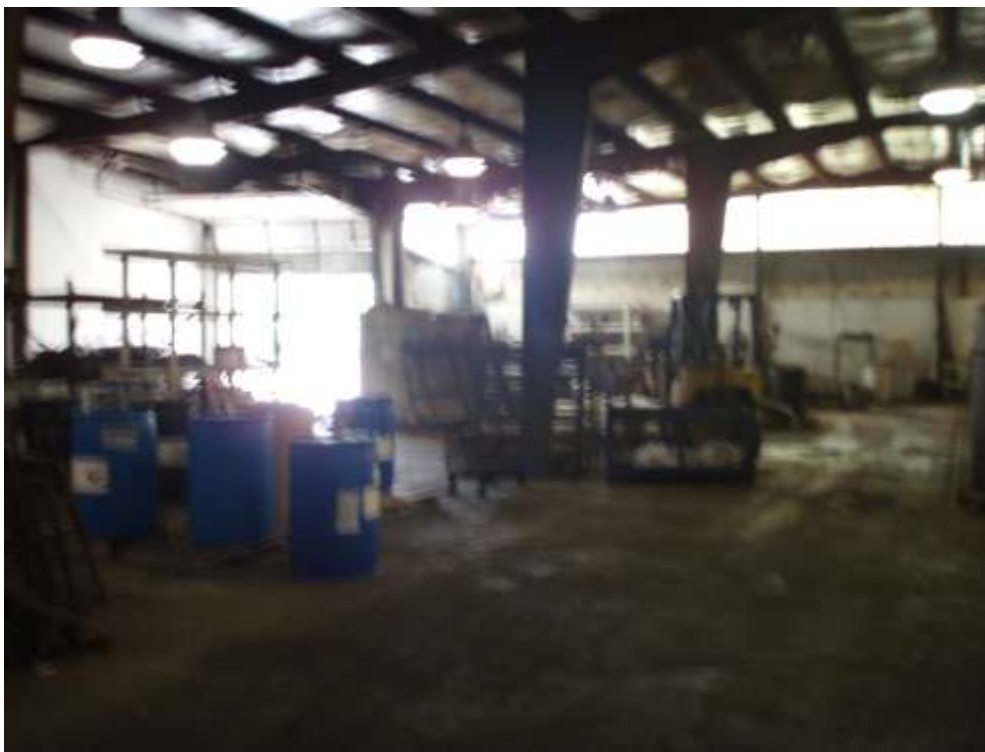
Various equipment and raw material storage.
Located on South/West side of facility.

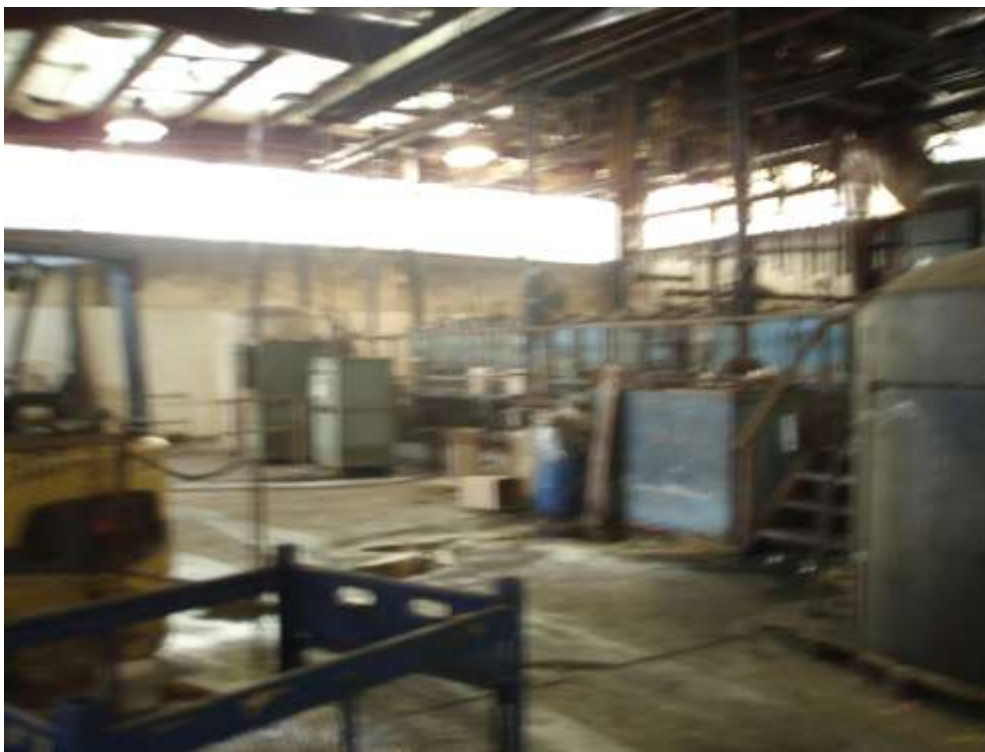
Zinc plating line. Liquid was located on the floor near the plating line.

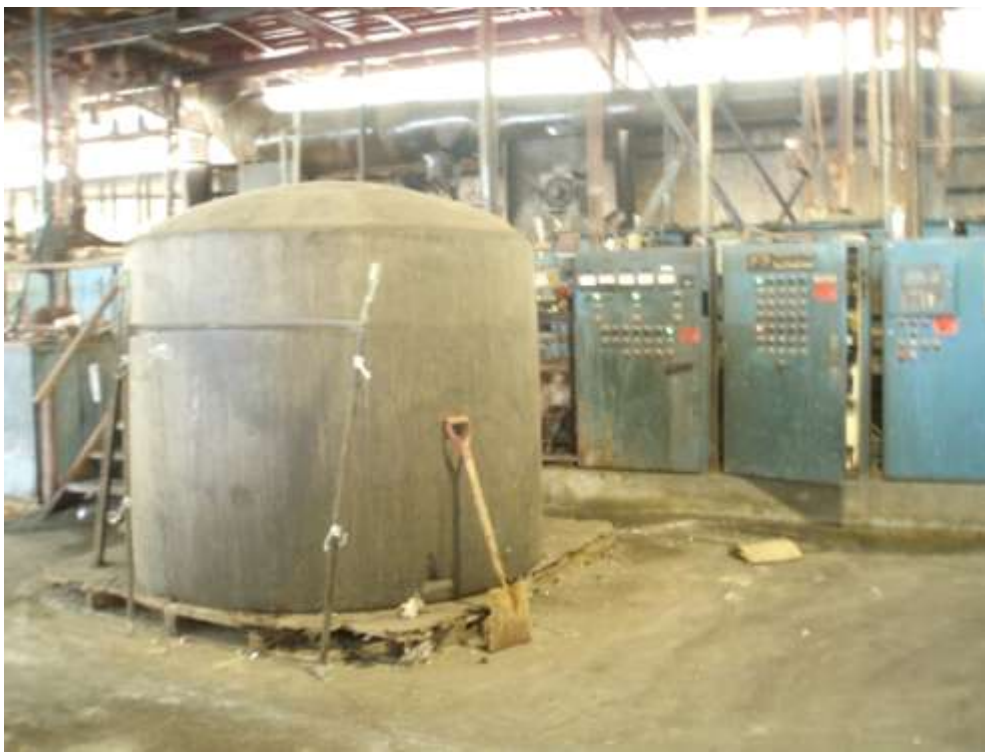
Tank storage of "working solution."

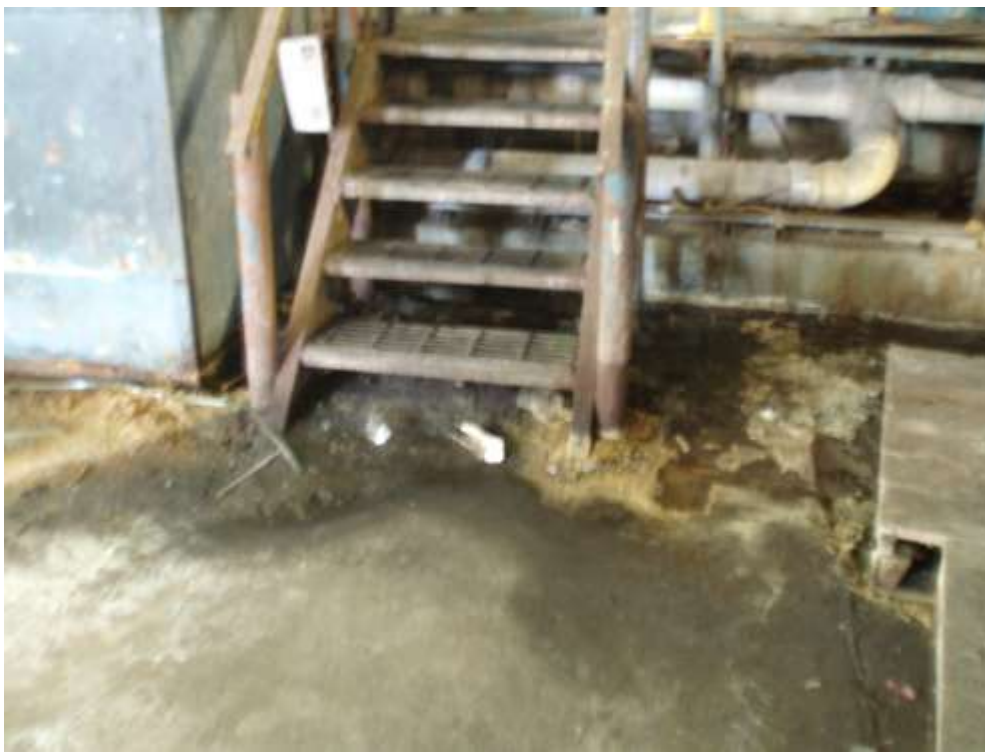
Containment pit was located underneath zinc plating line. Kitty litter was being used to absorb spilled material.

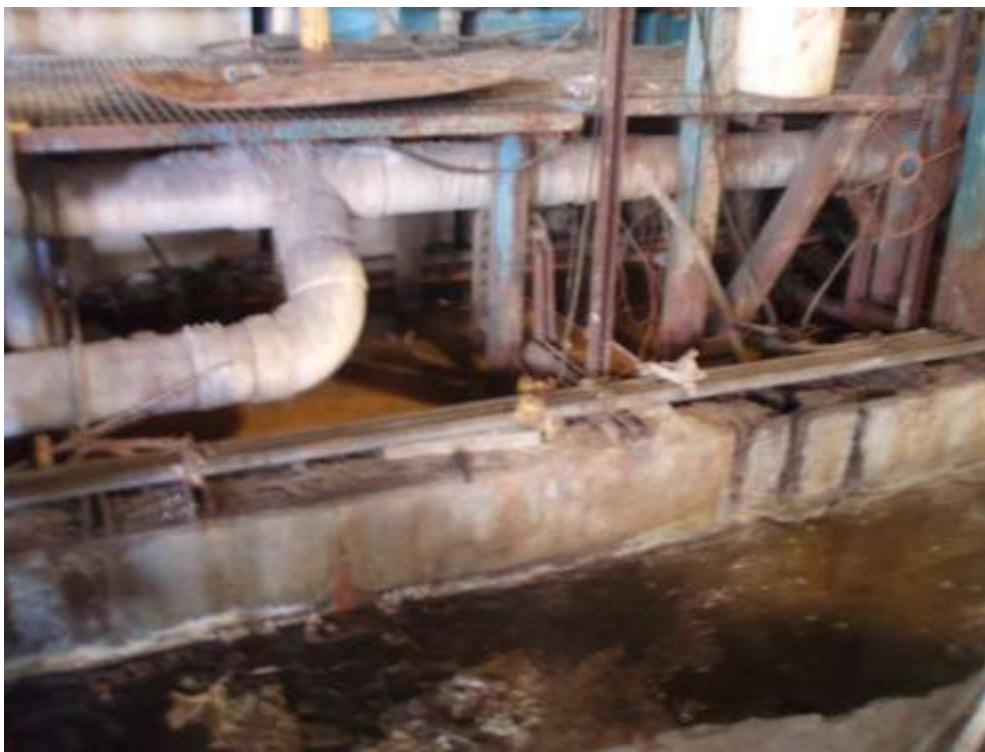
Liquids were being stored on the floor and within the containment pit of the zinc plating line.

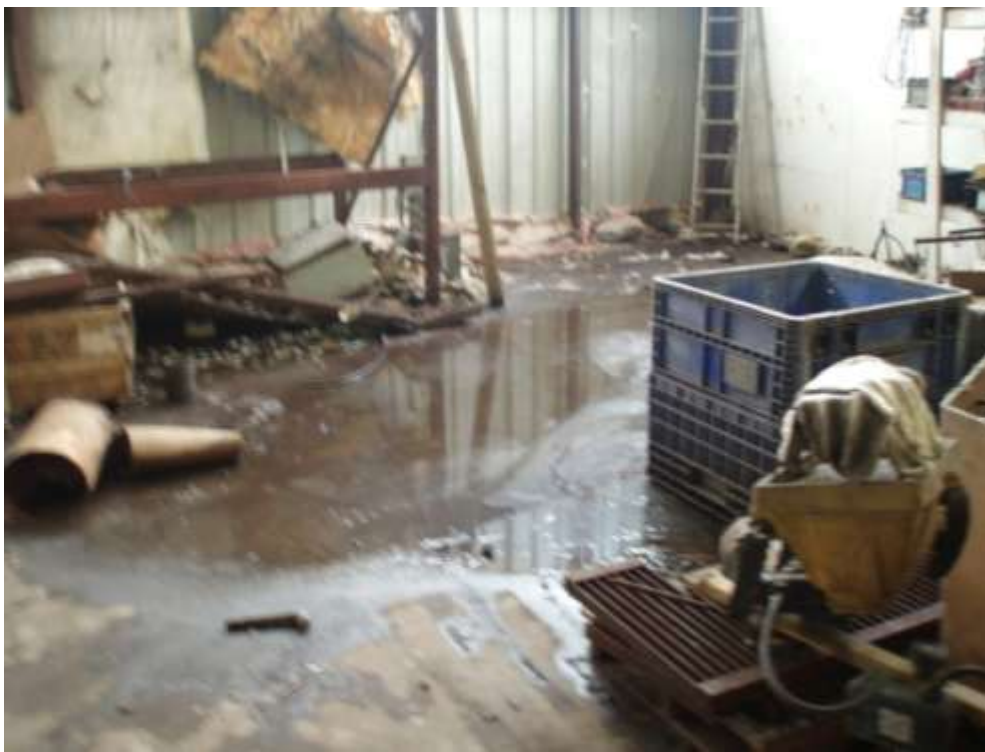
Liquid was located on the floor of the South/West of the facility.

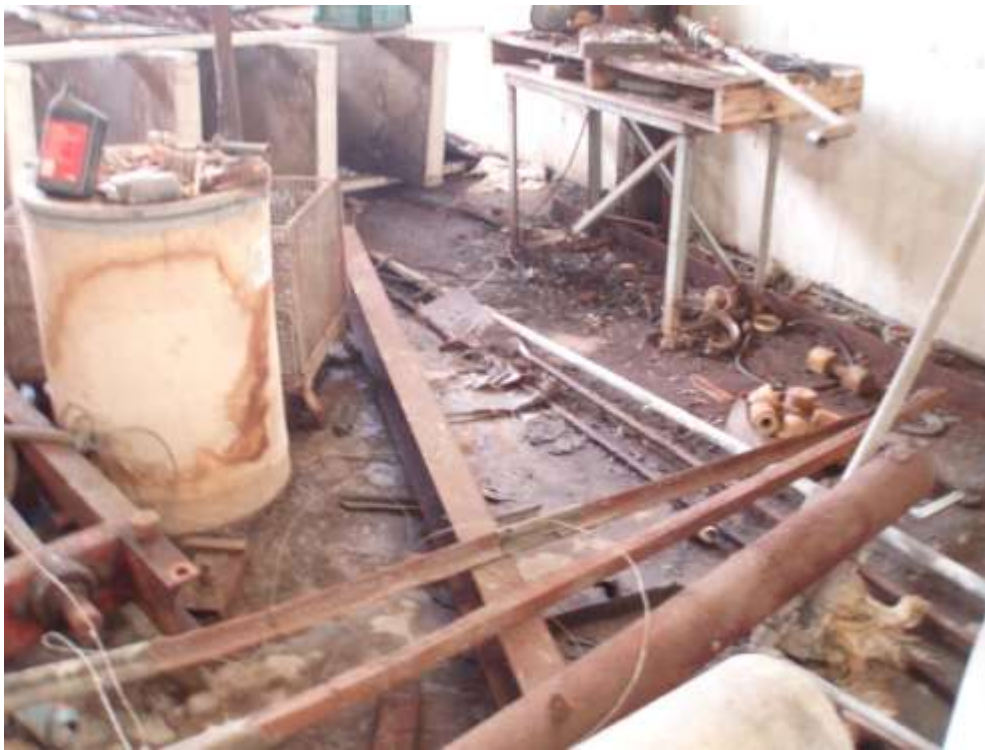
Un-identified material and equipment was located on the floor of the South/West side of the facility.

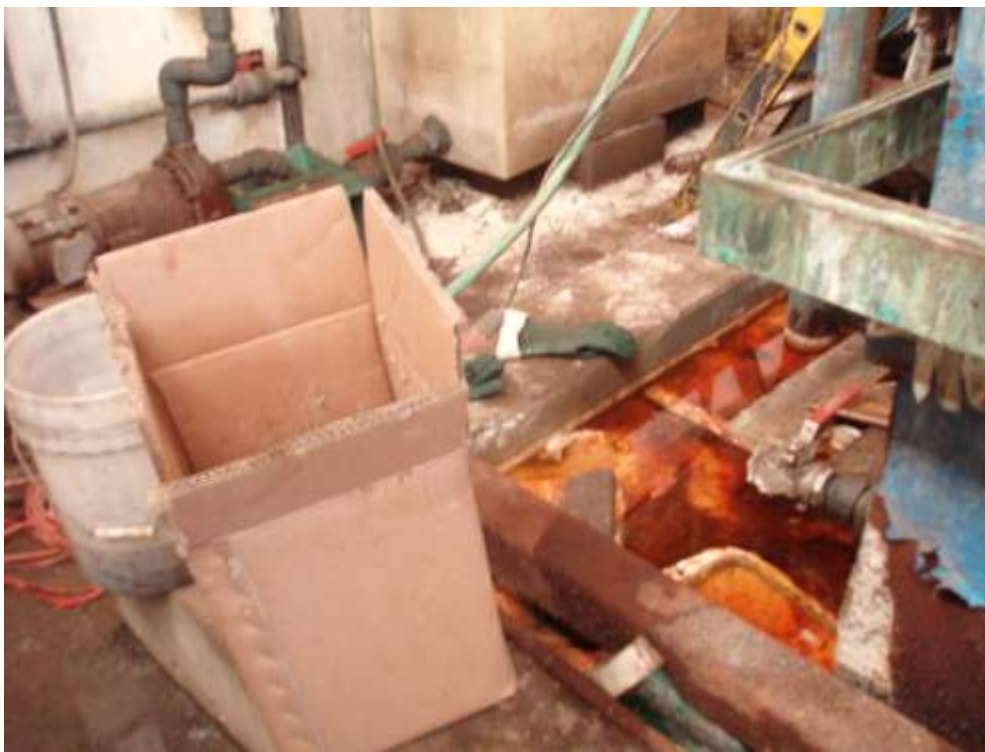
West side of zinc plating line. Red liquid was located in containment pit of line. Material was also being accumulated and stored on the floor near the line.

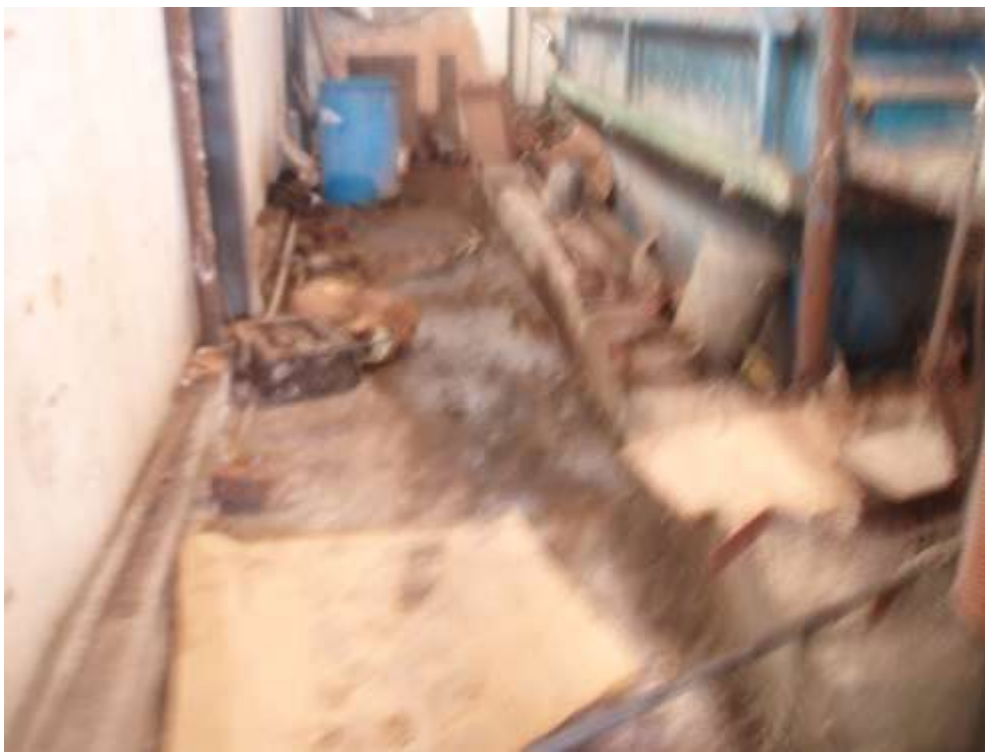
Floor surrounding zinc plating line, located in the South/West room. Debris and material were located on the floor surrounding line.

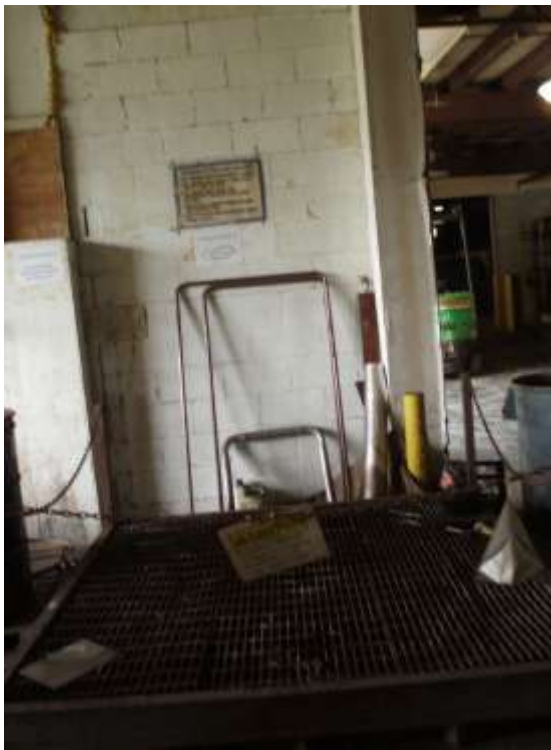
Hazardous waste storage area. No hazardous waste was being stored in this area at the time of the inspection.

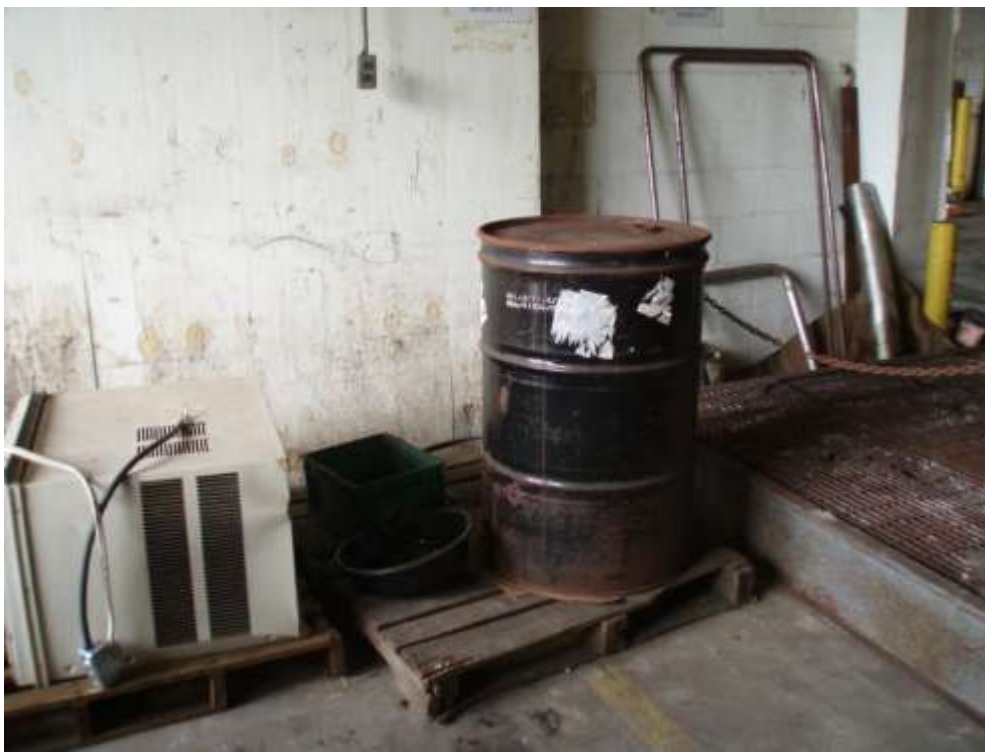
SAA 55-gallon container, F008, was not being stored at or near point of operation and was not labeled correctly.

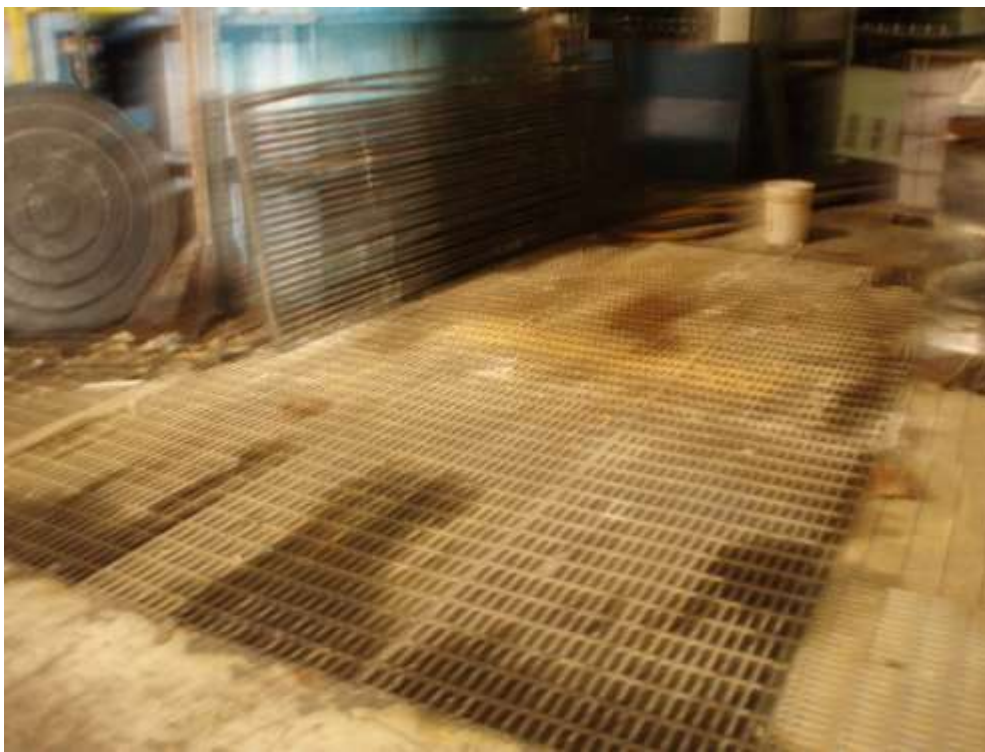
Trench with a grate, located in maintenance room, on West side of facility, was located within the floor. Liquid was being stored within the pit. Cleaner collects inside of grate and is pumped to WWT unit.
